Manhole Inspection Summary

Manhole # S05AA2003MH

Inspection ☐ Is Incomplete Rating: **4) Poor**

Location Address: **3106 PARKINGTON AVE**

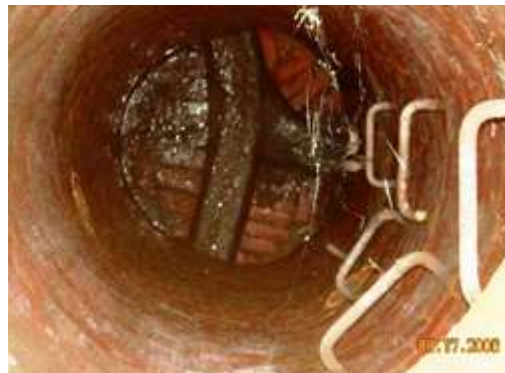
Top View

Frame leaks. Adjustment and Barrel infiltration.
Bench debris.

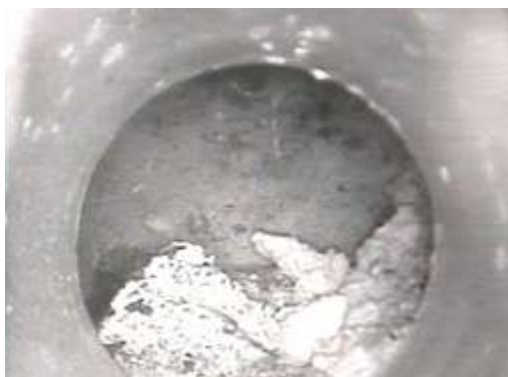
Clogged I4 pipe

Clogged I4 pipe.

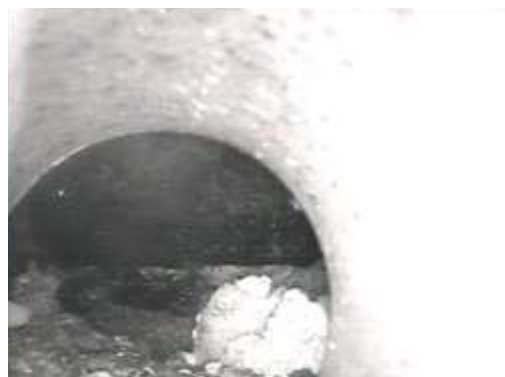
Clogged I8 pipe.

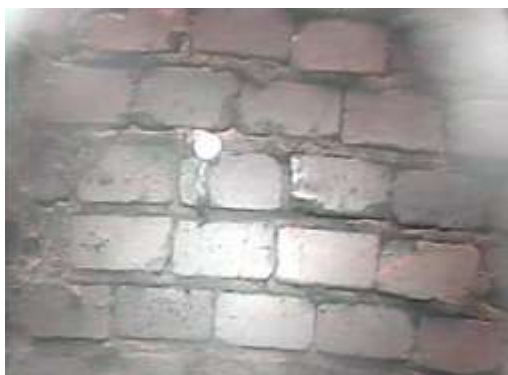
Defect

Missing step. Barrel deterioration and infiltration.

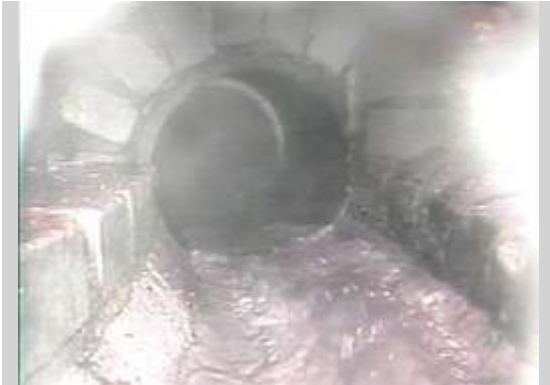
10 in. Circular Gravity Sewer Pipe Out @ 12 O'Clock

Bench and Channel deterioration.

Infiltration: **Evidence** Pipe Seal Cond: **Broken**

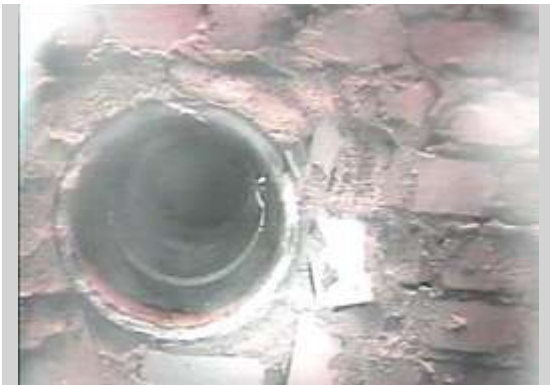
8 in. Circular Gravity Sewer Pipe In @ 3 O'Clock

Infiltration: **Evidence** Pipe Seal Cond: **Roots**

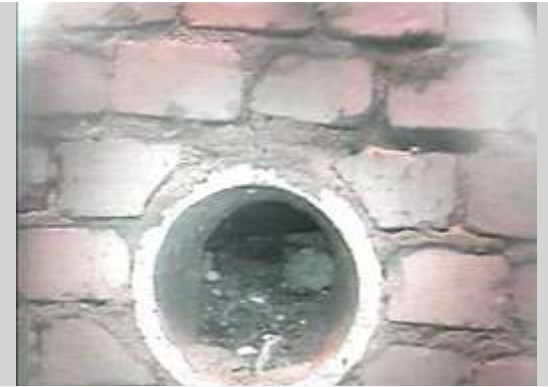
Pipe In @ 4 O'Clock

Deposits: ☐ None ☐ Mud ☐ Sludge ☒ **Debris** ☐ Grease

Silt Depth: **3** (in.) Deposits Extent: **Medium**

Infiltration: **Evidence**

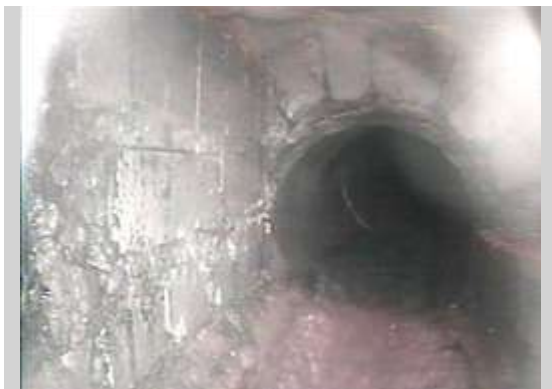
Pipe In @ 7 O'Clock

Channel deterioration.

Pipe Seal Cond: **Cracked**

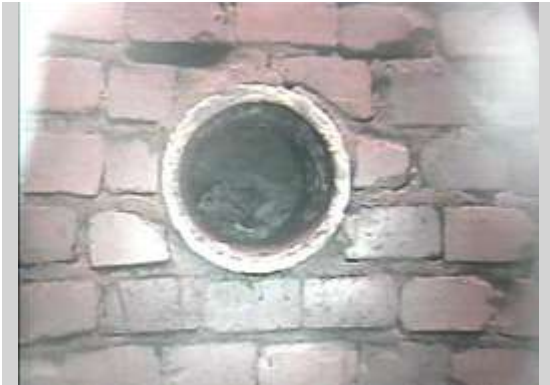
Pipe In @ 8 O'Clock

Barrel deterioration and infiltration.

Silt Depth: **6** (in.) Deposits Extent: **Heavy**
